Lovell Invasive Plant Prevention Committee

# Invasive Aquatic Plant

Screening, Marking & Mapping Survey

CUSHMAN POND

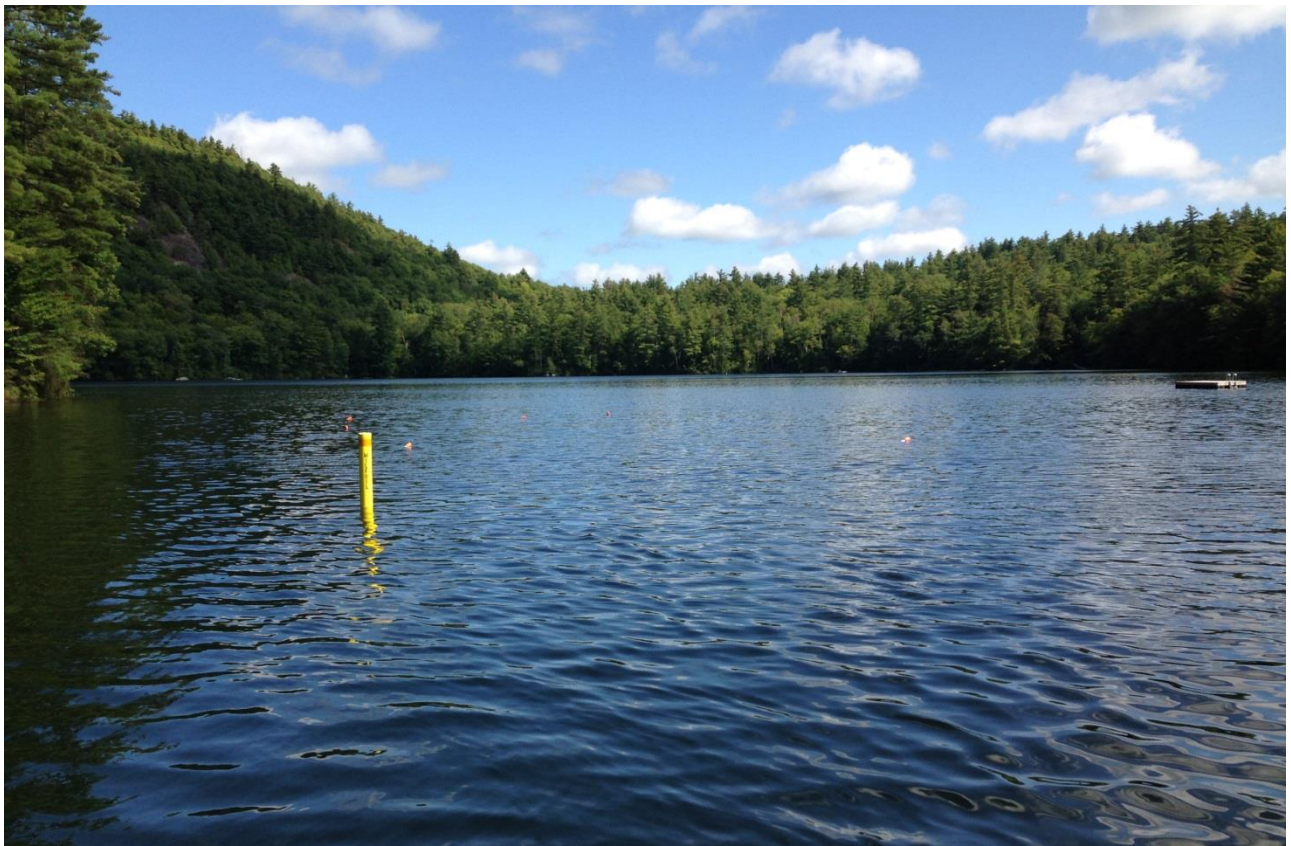
*Milfoil- infested area adjacent public boat landing, Cushman Pond*

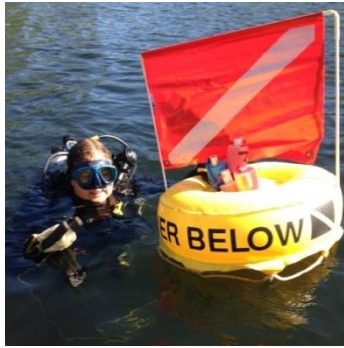
**Day 3**– On September 15, 2014 the same team of two LWRMA surveyors surveyed the deeper, central portion of the pond, working methodically across the area along spaced parallel transects. This survey confirmed the findings made during the exploratory probes on day 2, i.e., that the substrate in this region of the pond is largely unconsolidated muck, and that the area is devoid of plant life. Much of it deeper than 21 feet, dark and sterile, we now know that this part of the pond is *not* littoral.

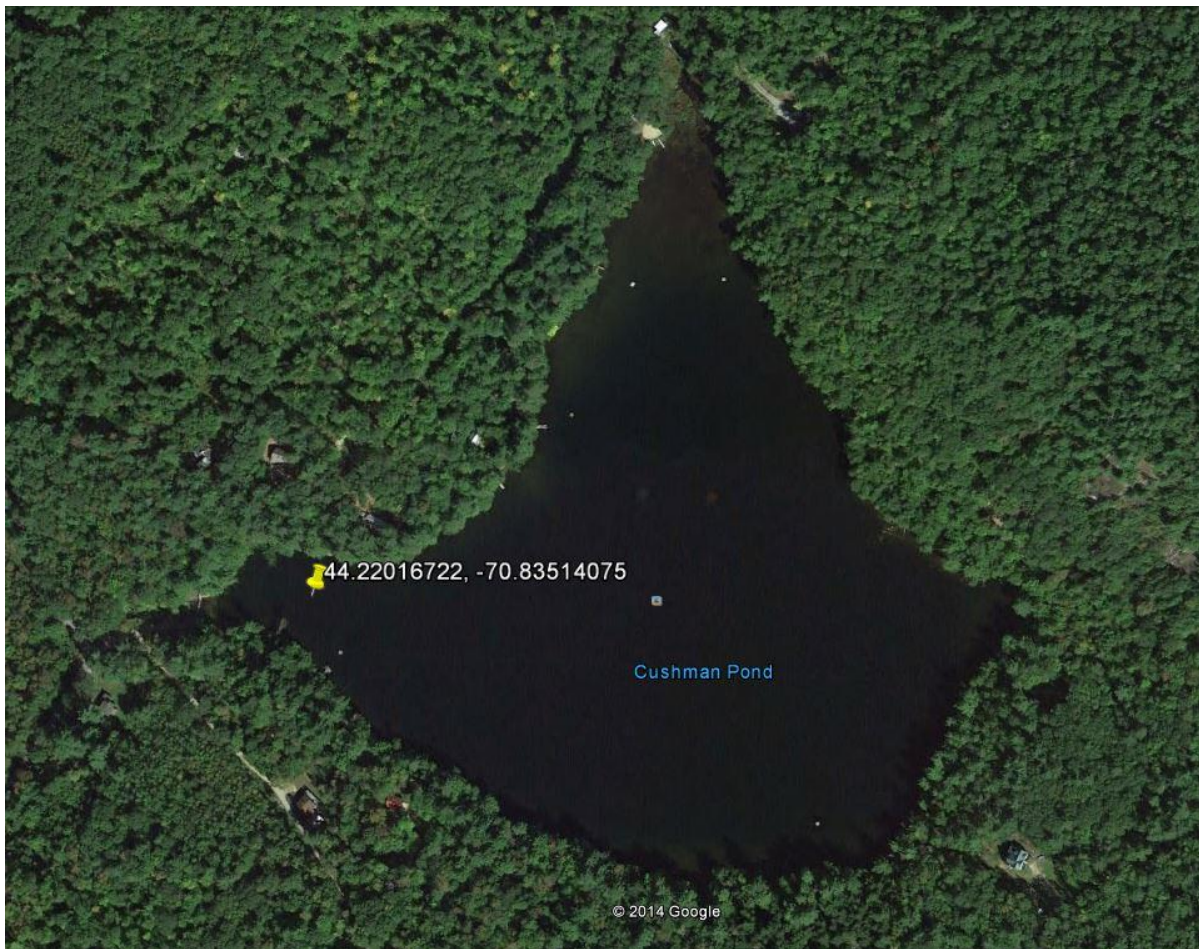
**The level-3 survey resulted in the detection of variable water-milfoil in one area of the pond only.** This area is in close proximity to the active control site in the western cove. These plants were apparently missed by the control team.

This map shows the approximate location of the infested area.  
Coordinates: 44.22016722 N, -70.83514075W

1. A full level-3 survey of Cushman Pond should be done annually, up until such time as there has been three consecutive years of “no VWM detected” (achievement of complete eradication, as defined by the DEP). Having determined that the central portion of the pond is not littoral significantly simplifies the process of conducting a level-3 survey.
2. All VWM found by surveyors should be marked, mapped, characterized and documented.
3. Near-shore areas should be screened by surveyors working from a boat or snorkelers; deeper areas should be surveyed by SCUBA divers.

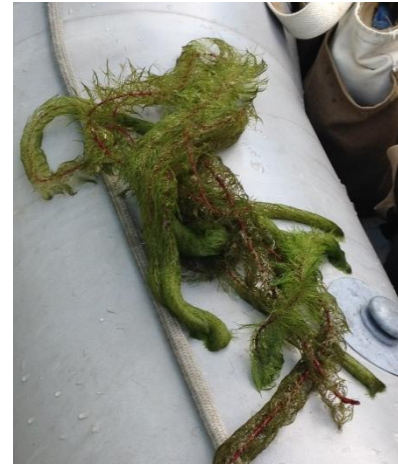
*Several VWM stems were inadvertently detached during the survey. All fragments were retrieved and later disposed of.*
